SPECIAL CONSUMER RREPORT:

Honda Gold Wing Rear Hub Failure

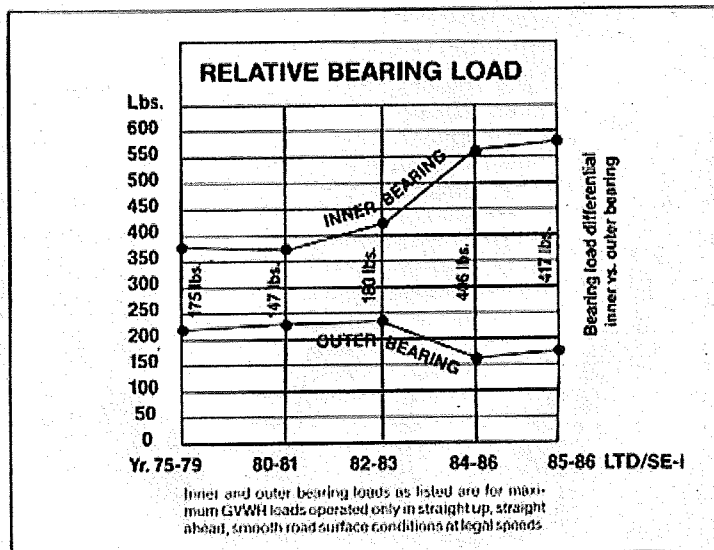
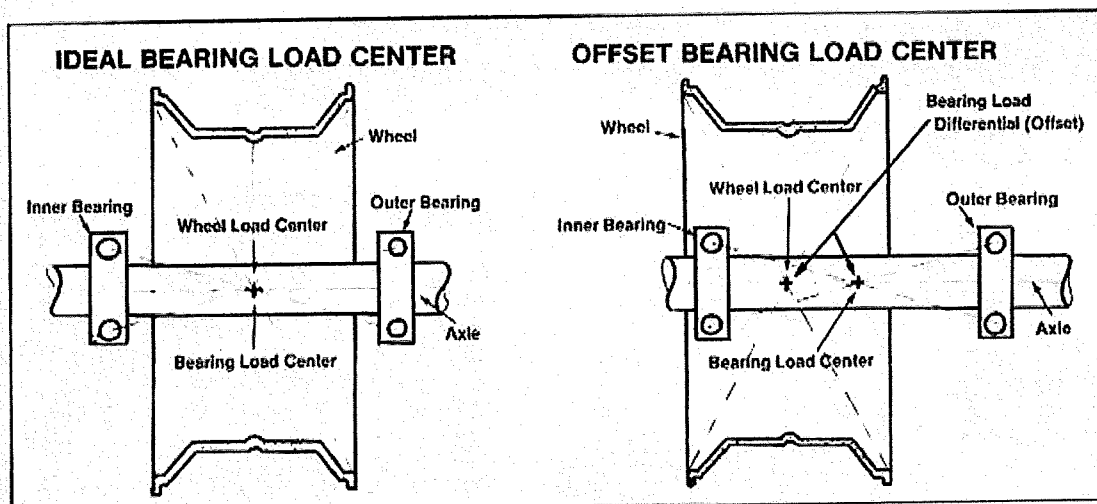
Since the axle and wheel bearing components are made of steel, this road impact is transferred back to the softest material in the system: the cast alloy hub that supports the wheel bearings. Because 78 percent of the load is supported by the inner wheel bearing, road shock is also transferred to the alloy inner hub disproportionately.

Over time, this hammering of the inner rear wheel hub "spins" the alloy material away from the source of the impact, resulting in expansion of the inner wheel bearing support. Eventually, the inner wheel bearing will loosen, and play will develop between the hub and the bearing.

And now we have a situation that can contribute to all kinds of serious problems, such as handling instability or outright bearing failure. It is characterized, in the early stages of failure, by a "clicking" sound at the rear wheel that worsens steadily, and a general deterioration of handling response.

There is a retrofit "kit" available for the 1984 and 1985 Gold Wings. "Kit" may be something of a misnomer; the replacement set includes a complete new 1986 rear wheel assembly — with bearings and steel-collared hub — and a final driven flange. Installation of this kit falls under normal warranty procedures.

A good idea is to check the rear wheel carefully during any tire change to insure that there is no discernible play between the hub and the inner wheel bearing. If your machine has several thousand miles on it, and you tend to ride it reasonably hard, it might be a wise precautionary move to have this "kit" installed before rear hub problems occur. Prices will vary, of course, depending on where you live, but a ballpark figure should be somewhere near \$225 for parts (if purchased as a set — individually the parts would cost about \$270), and \$50 for labor.
