Title: <b>Seagull Engine Timing Assembly</b>		
Scale: <b>2 : 1</b>	Projection: Third Angle	Dimensions: <b>in</b>
Drawn by: <b>C Lamont</b>	Date: <b>2010-11-03</b>	Drawing No: <b>ME014-25A</b>

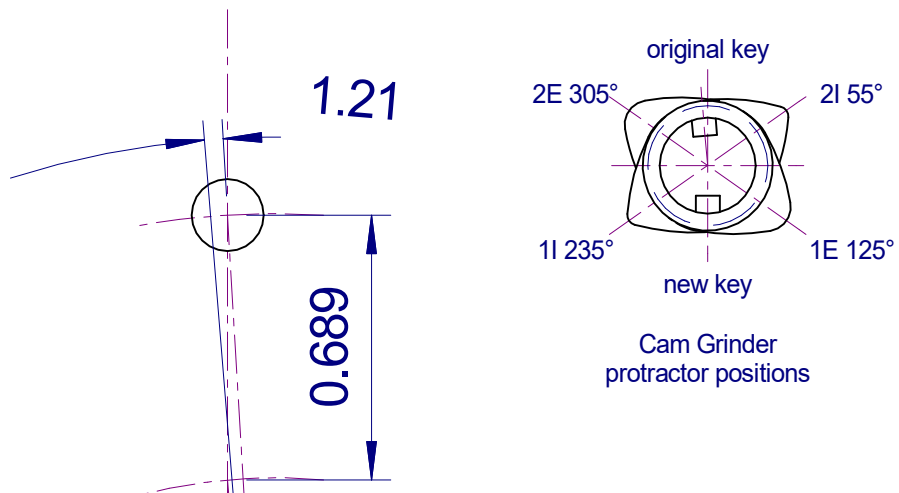
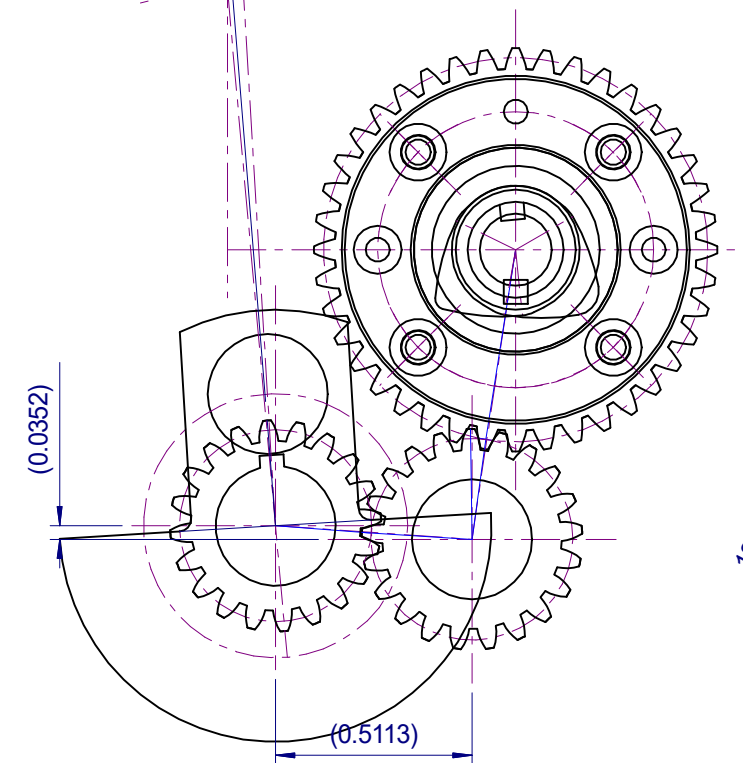
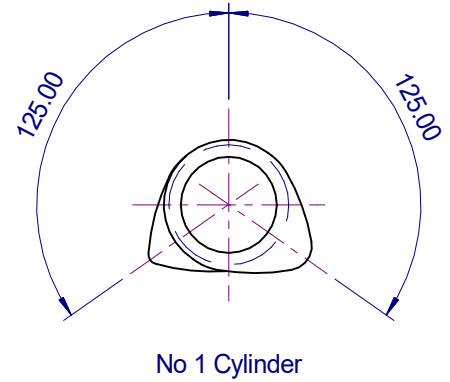
- 1 Cam gear tooth and camshaft key should have been aligned vertical at top dead but camshaft assembly error means the keyway is out of place and would retard timing by 5° on camshaft. New keyway to be cut 175° anticlockwise from existing, and gear rotated 180°.

- 2 Gear meshing determines position of crankshaft pinion  
At both meshing points the gear teeth are almost but not exactly aligned with the gear centrelines. This is a coincidence.

- 3 Because the engine is Desaxe, top dead centre is not where the crank is vertical but when the crank throw and connecting rod are in line (and bottom dead centre is not 180° from top dead). Crank angle at TDC: 3.42° at BDC: 185.10°

- 4 The crankshaft keyway is aligned with the crank.
- 5 These considerations determine the relationship between the teeth and keyway in the crankshaft pinion. The keyway centreline is 1.21° clockwise from the tooth centreline, looking at the timing end.

- 6 The ignition timing magnets are on the horizontal centreline.
- 7 A one thou error in the centering of a keyway produces an error of approximately one degree in crankshaft timing
