Cub Crafters, Inc. Considers Compliance Mandatory

SUBJECT: UN-COMMANDED FLAP RETRACTION

MODELS AFFECTED: CC11-100 S/N00002 thru S/N00031

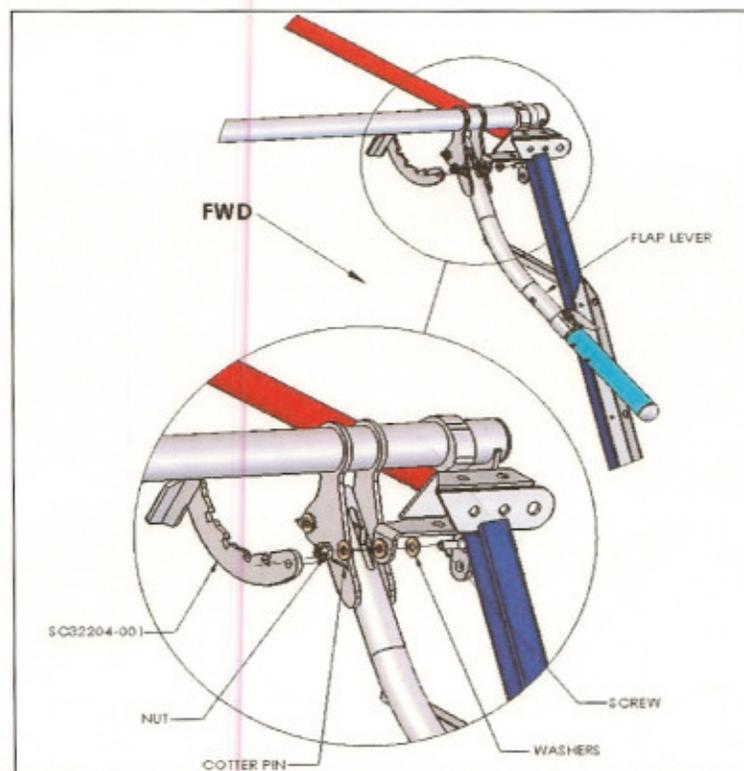
Figure 1

PURPOSE: THE FLAP LOCKING MECHANISM HAS THE POSSIBILITY OF DISENGAGING CAUSING UN-COMMANDED FLAP RETRACTION.

1. Remove existing SC32204-001 by removing hardware as shown in Figure 1. Retain hardware and discard SC32204-001 and cotter pin.
2. Rotate flap lever arm fore and aft while applying pressure inboard or outboard to center and align flap cross bar with fuselage centerline as necessary.
3. Install SC32204-001 Revision F using same hardware and new cotter pin (AN380-2-2). SC32204-001 should be centered thru flap lever slot (see Figure 2). Additional washers (AN960-10 or AN960-10L) may be used to shim SC32204-001 to achieve center position. Do not use more than 4 washers per side to shim.
