Broken Trailing Edges On A Super Cub

Oil Breather "Fixes" on Continental Engines

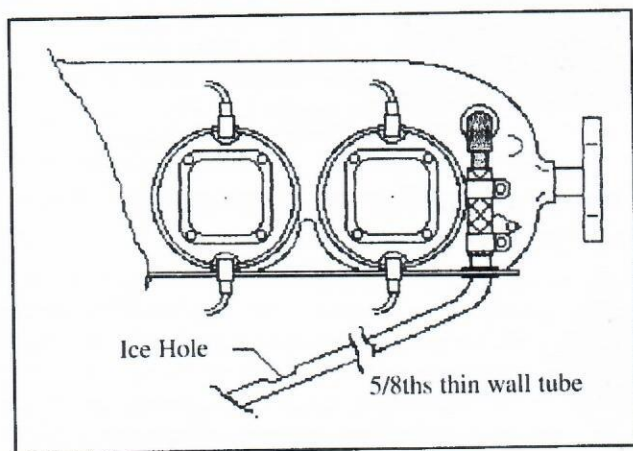
The "Normal" installation, as built, showing how the breather fitting is pointed vertically downward from the crankcase.

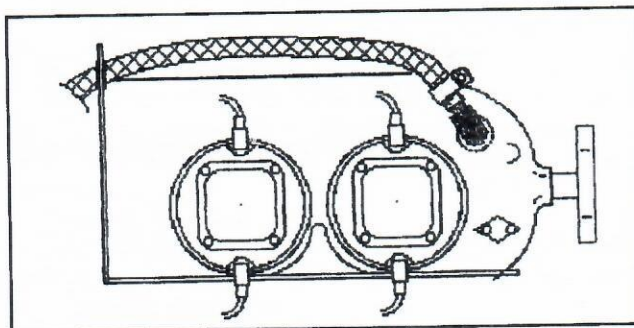
Hose over the top. The oil which condenses on the walls of the rising portion will return to the crankcase. Also, don't forget the breather relief hole, preferably placed behind the vertical baffle.

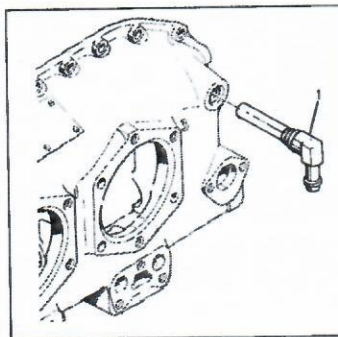
Their cure was to modify the brass right angle breather tube fitting (part number AN 842-10) which screws into the top right hand corner of the engine and attaches to the hose leading to the breather tube. The modification is to attach a tube to the end of the fitting which goes into the engine. The purpose of displacing the pickup opening of the fitting is to "hide" the opening from the droplets of oil flung by the cam and the front gearing.

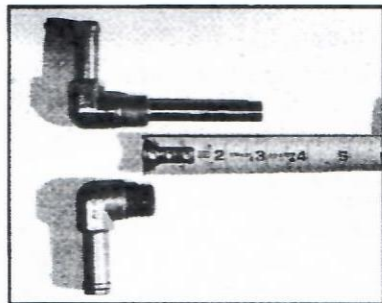
Comparing the stock breather tube to the modified breather tube. The modified version has an approximate 2 3/4" extension that is inserted into the breather tube cavity on the crankcase.

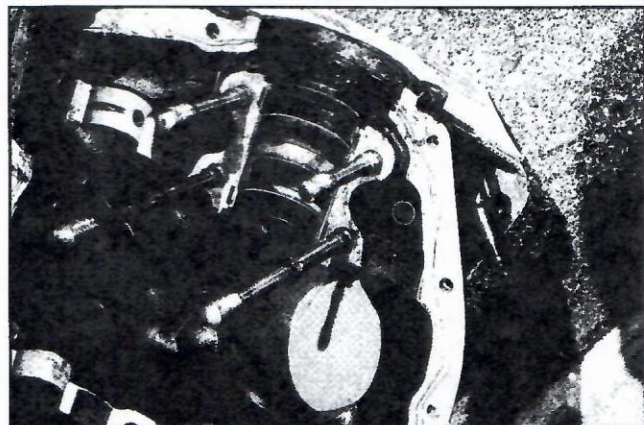
This view of the right side crankcase half shows the modified breather fitting installed. The extended breather tube is still recessed within the cavity and does not interfere with any component engine parts.

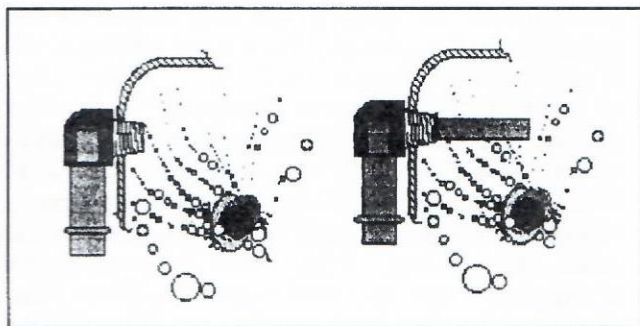
On the left, a stylized view of the oil droplets flung toward the opening of the breather's AN fitting. Some of the droplets are captured in the fitting and are blown out the breather and on to the belly. On the right, the extension is shown and indicates how its opening is not subjected to the ingestion of the droplets of oil.

The two sketches tell the story. The added tube is copper, brass or steel with the OD machined to fit inside the bored out portion of the AN 842-10. The difference in OD of the pipe and the ID of the fitting should match the process used to join them – about five thousandths for brazing. Brazing is stated to be compatible with the other materials of the engine.
