# The V-Tail Bonanza— Breaking of a Legend

Reprinted from the February 1, 1980  
issue of The Aviation Consumer

Beech's V-tail classic has a disturbingly high record of in-flight airframe failures, while the straight-tail 33 and 36 Bonanzas almost never break.

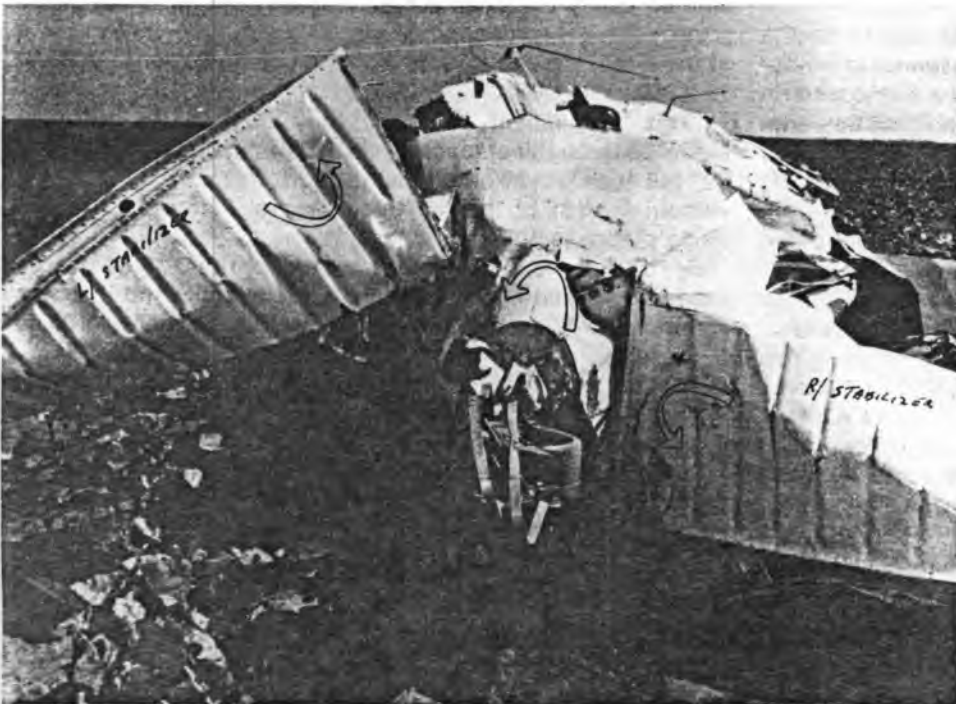
As Beech strengthened the wings, more failures began to occur in the tail.

pattern over the years. With the early models, the wing would fail and the entire tail would come off as a unit. But as Beech beefed up the wing and increased the chord of the stabilizer, the more recent ones had an entirely different break pattern. These later models seem to fail in the fins; the fin leading edge folds over—either up or down—sometimes symmetrically, sometimes asymmetrically.”

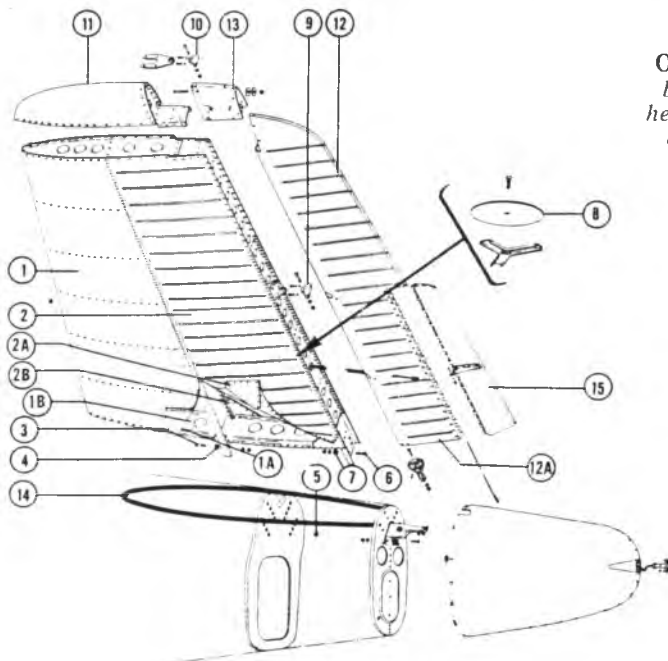
One key to the Bonanza's breakup problem may lie here: the V-tail. Structural design, ruddervator mass balance and trim cables may all play a part.

If Tolve's results are extrapolated to 18,000 ft. (the service ceiling of several of the Bonanza models), they show that only 2.2 inch-pounds aft unbalance beyond Beech specs would allow the ruddervator to flutter. (Slack rudder cables would degrade even this small margin significantly.)

More practically speaking, this amount of unbalance could easily come from repainting the ruddervators without rebalancing afterwards. According to Beech, an average repaint job adds about 2.5 in.-lbs. of imbalance—enough to cause flutter under some conditions. It is not really an exaggeration to say that proper ruddervator rebalancing after a repaint job can be a life-or-death matter for a V-tail Bonanza pilot.

How can you buy more protection? Rebalance your ruddervators with as much lead in the counterweights as Beech specs or the room available allows. Keep your rudder and tab cables in good condition and at the proper tension. Keep the surfaces clean and the drain holes open. Don't take off with ice on or in the control surfaces.

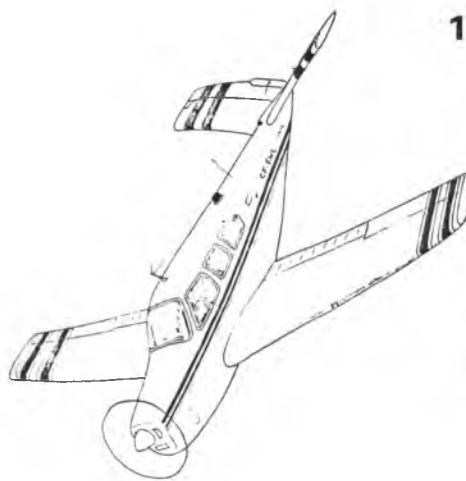
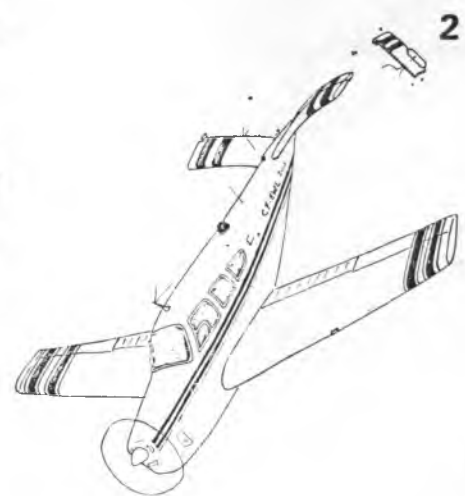
This series of drawings depicts the in-flight breakup of a V35 TC near Pas, Manitoba in 1972. The drawings are by Bouko James Kor, who did a computerized trajectory reconstruction of the accident. The aircraft apparently stalled in IFR conditions after a vacuum pump failure, then pitched down into a high-speed dive, with wings and tail bending under the stress (1). The right ruddervator separated (2) causing the plane to pitch beyond vertical and shed its left wing (3). At this point, the engine separated (4) and general disintegration followed (5).

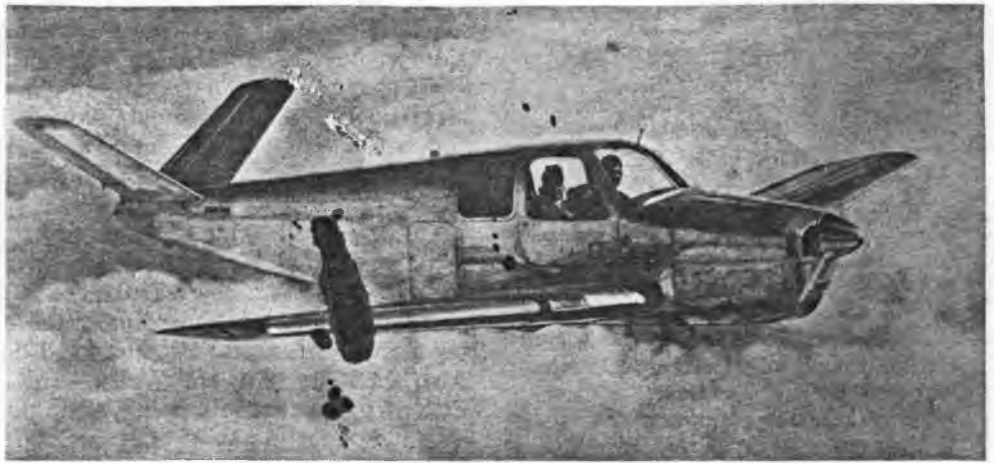
This weight-conscious philosophy led Beech to use a daring structural technique. Outboard of Wing Station 66 (just outboard of the landing gear), they left the shear web out of the wing spar. Any time lift is being created, there is a bending moment in the spar. That results in what is called a shear between the top and bottom caps of the spar. The shear web, normally just an aluminum sheet, takes out this shear load. Beech decided to use the leading edge skin to carry the shear. This made the leading edge wing skin what is called "primary structure" (i.e., if it fails, the airplane fails). In this way, Beech may have saved perhaps five pounds.

These stress concentrations, taken together, virtually paint a dotted line on the wing of the straight-35 which says "Break Here." Thirty-seven of the 49 structural failures (76 percent) reported in Beech Report 103 broke at Wing Station 66.

The first prototype "straight 35"—the seminal Bonanza with the seminal structural weakness.
