National Transportation Safety Board Aviation Accident Preliminary Report

Location:	Conway, SC	Accident Number:	CEN22FA419
Date & Time:	September 14, 2022, 12:22 Local	Registration:	N62FC
Aircraft:	Piper PA-28R-201	Injuries:	2 Fatal
Flight Conducted Under:	Part 91: General aviation - Personal

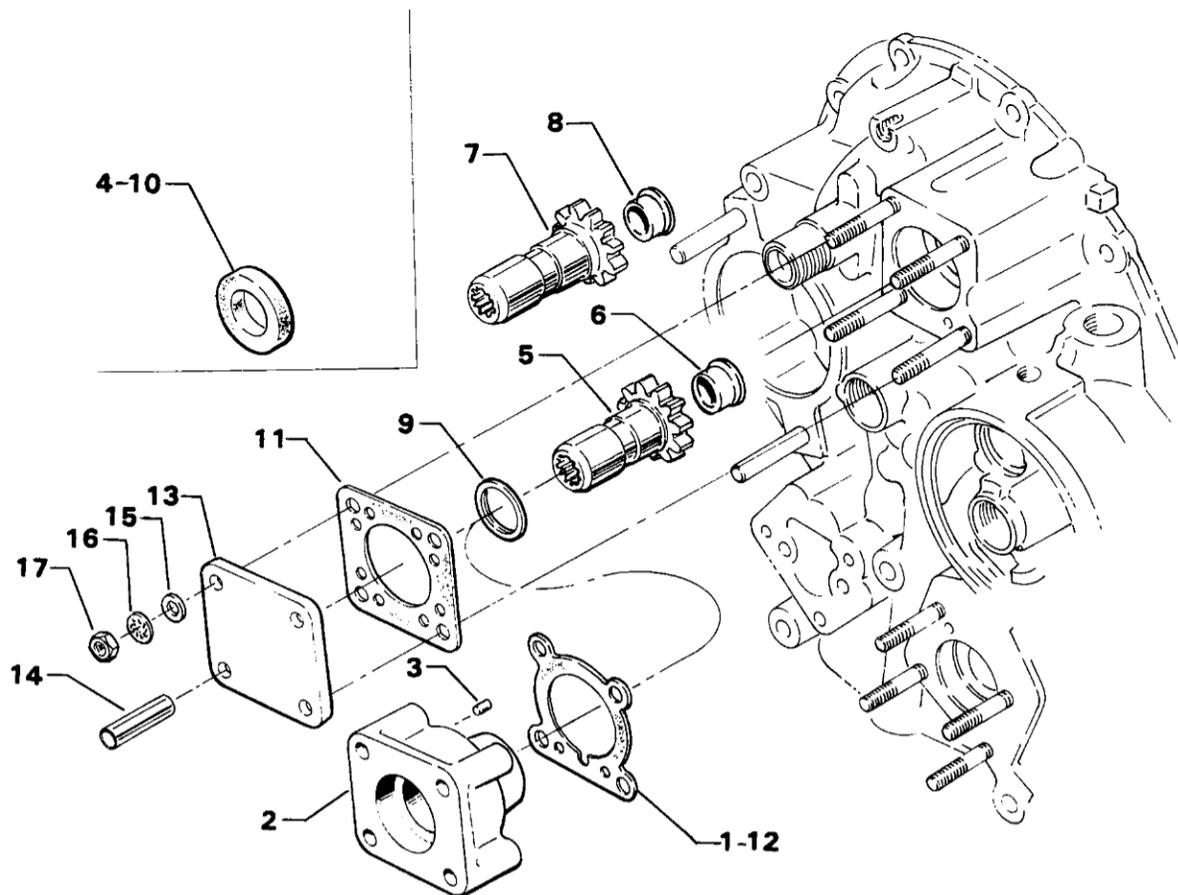
A postaccident examination of the engine revealed that the Nos. 2, 3, and 4 connecting rods separated. The left engine crankcase half was fractured inboard of the No.4 cylinder mounting pad. The Nos.3 and 4 connecting rods were separated from their respective crankshaft rod journals and the damaged rod ends were visible through the crankcase fracture. During disassembly of the engine, a vacuum pump cover (item No. 13 in Figure 1 below from the Lycoming Parts Catalog) was removed from the vacuum pump drive pad and no gasket (item No. 11), or remnants of a gasket, were found. Other engine components were removed, and all had remnants of a gasket despite the thermal damage.

Figure 1: Excerpt from Lycoming Parts Catalog, View of Engine Accessory Case
