# Aviation Investigation Preliminary Report

<b>Location:</b>	Coldspring, TX	<b>Accident Number:</b>	CEN23LA172
<b>Date &amp; Time:</b>	May 3, 2023, 13:29 Local	<b>Registration:</b>	N28HE
<b>Aircraft:</b>	Piper PA-34-200	<b>Injuries:</b>	2 Serious
<b>Flight Conducted Under:</b>	Part 91: General aviation - Instructional

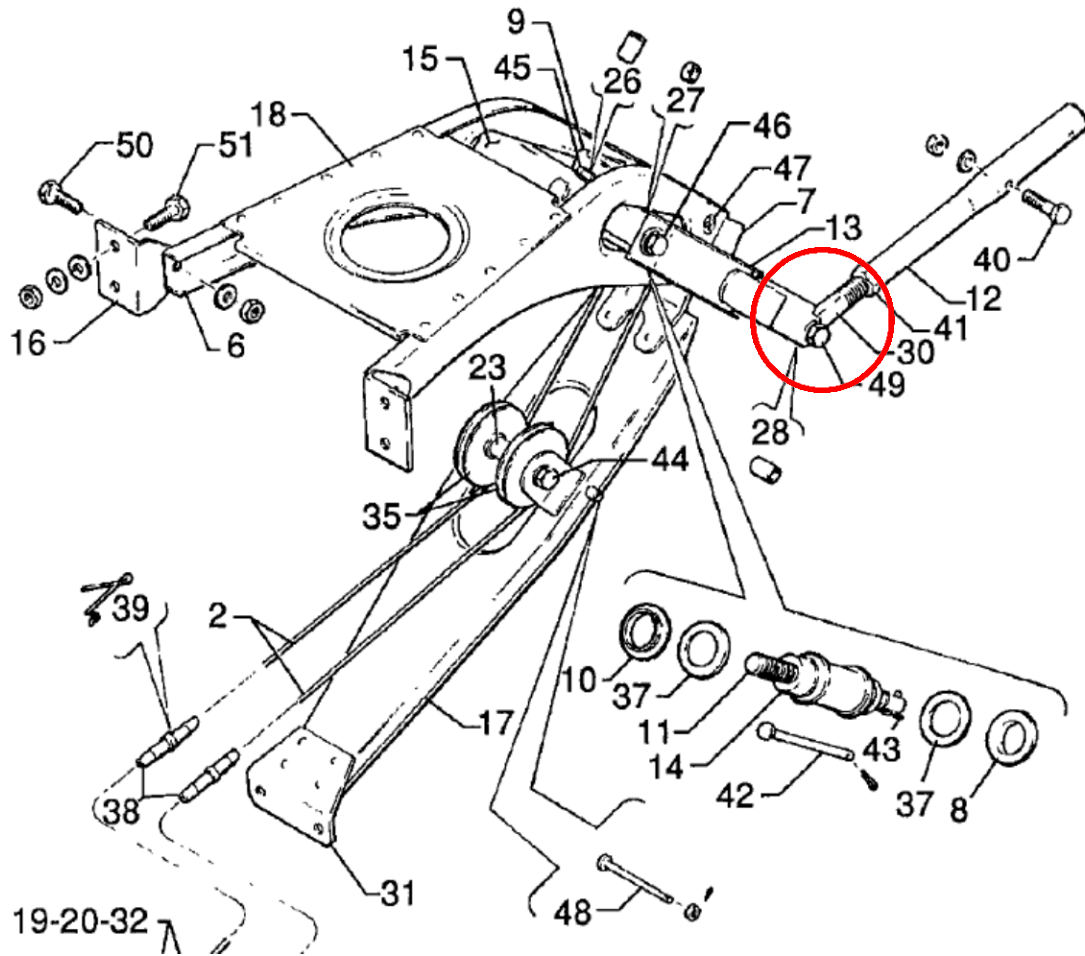
Figure 1: Illustrated Parts Catalog (Part Nos. 753-816)

A postaccident examination revealed that the bolt (item 49 in figure 1) which connects the stabilator trim rod assembly (item 12) to the stabilator link assembly (item 13) was missing. (Figure 2)

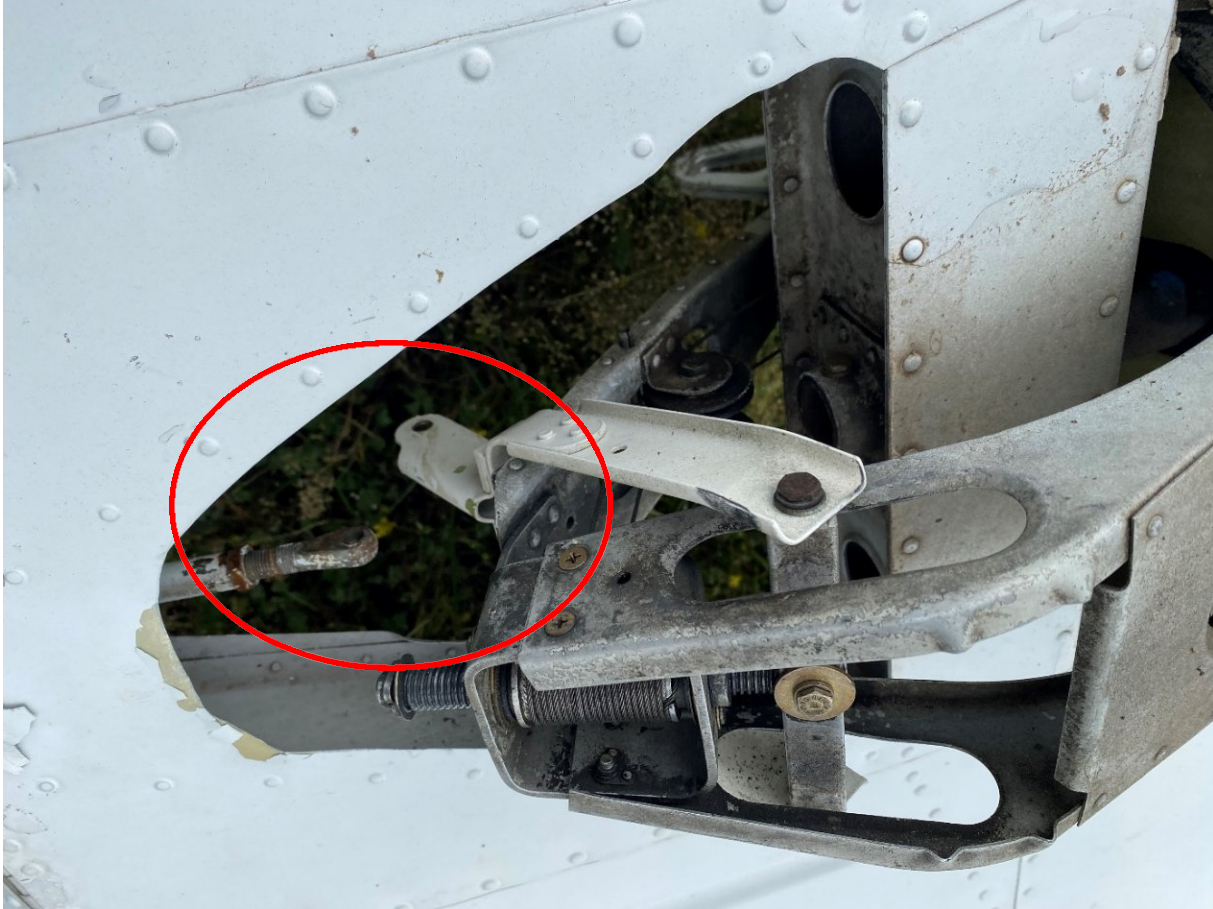
*Figure 2: Photo of the stabilator trim assembly (Photo courtesy of the FAA)*
