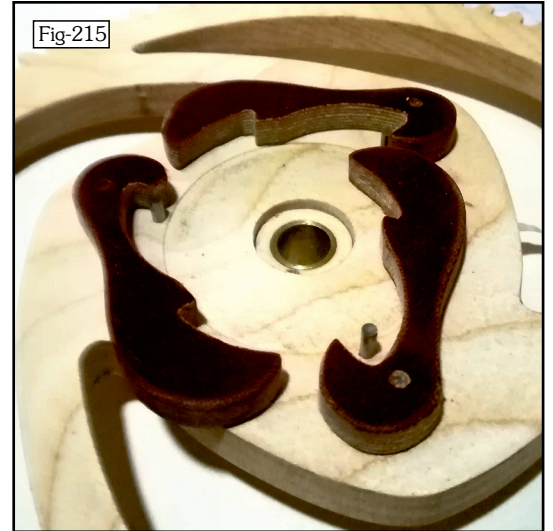
The later two probably could be cut on the Denford but I've not yet dipped my toe in that water so I settled for Tufnol and the result can be seen in Fig-215 where the Pawls are mounted on the Main Drive Gear.

Considering the options open to me as far as the material with which to make the new Pawls, I was concerned that - now I know the Drive Weight is likely to be in excess of 3kg, (I had originally anticipated about 2kg or less) - Maple, Beech, Ash, Oak, Elm etc. are unlikely to be strong enough to withstand the forces involved for very long. Other options are, Tufnol, (a Phenolic Resin Laminated material which essentially has no 'grain'), Brass or Aluminium.

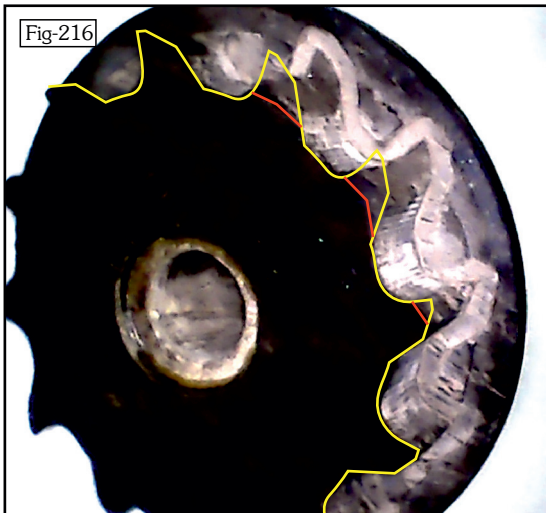
As there had been damage to the Pawls I was not at all surprised to find that when I dismantled the Winding Drum from the Main Drive Gear, there was also damage to the Ratchet. That is quite difficult to photograph so I've done some enhancements to Fig-216 where the Yellow line shows where the Ratchet teeth should be (were!) and the red lines indicate the damage which amounts to three of the teeth.

The Ratchet is already glued to the Winding Drum so affecting a repair to this is going to be fraught with issues.

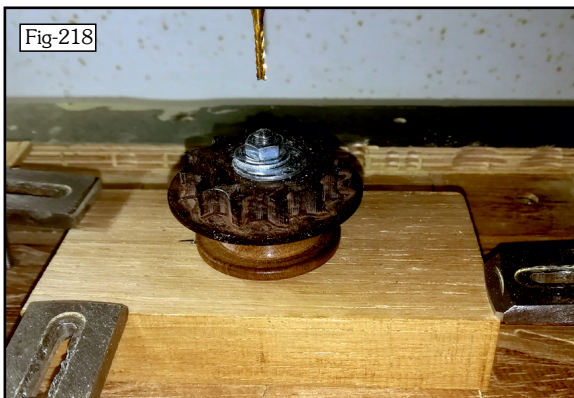
The Ratchet is now positioned on the Denford Table and Fig-218 shows it with a 2mm Ø burr at X0-Y0 but I've just realized that I haven't taken account of the precise orientation of the Ratchet Teeth . . . . . This is going to be important because initially I'm thinking of just inserting Brass teeth at the position of the three broken ones might do the job.

. . . . . Now I have correctly aligned the block, I've noticed that a fourth tooth has some damage so that will also be replaced.

Next I bored a close-fitting hole in a block of Oak which can be clamped to the table and milled a slot into which the M3 Grub Screw which clamps the Winding Drum to the Drive Spindle can fit thus arresting any potential movement.
