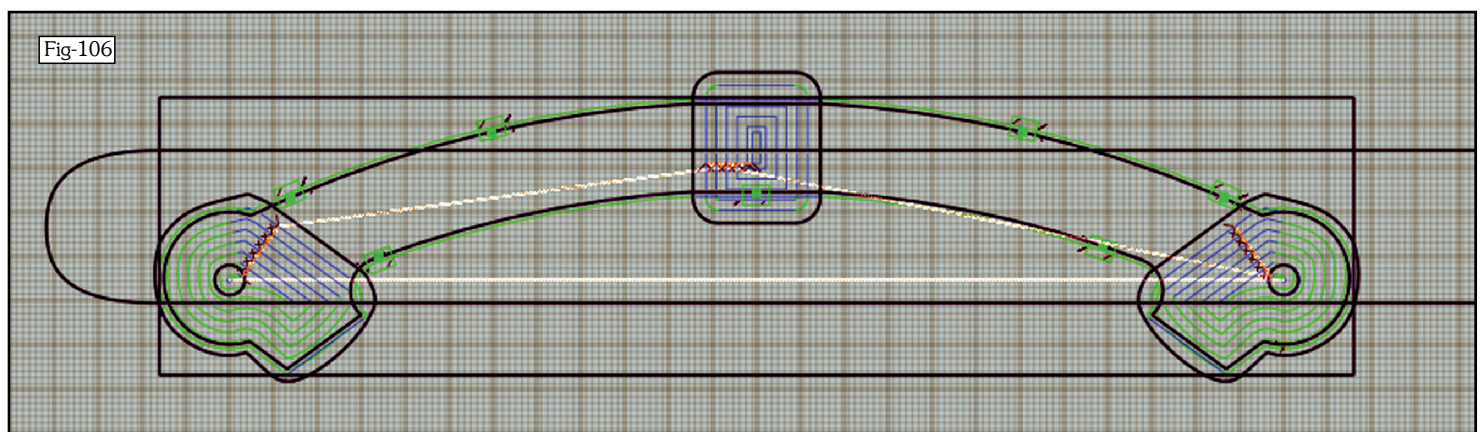
Well, I didn't make this mistake! It seems that either Mach3 or the Denford decided that I was doing too well today having skimmed both surfaces of the Front Frame 'B' sections with nary a problem, and even cut the joints and two holes in the first blank whilst also giving my grandson instruction in the use of the milling machine during which time I just let the Denford get on with cutting the outline. I knew it was going to take a while since I'd decided to take just a single cut down to the 11mm depth in ½mm increments and I just kept an eye on what it was doing occasionally. All was going to plan and the depth was at about 8mm when I had to spend a little more time on the mill. The next time I looked at the Denford it was cutting the blank in half !!! - The drawing in CamBam, Fig-106, from which the G-Code is generated has no line going from top to bottom but that is what was being cut when I got back to checking the Denford – the result can be seen in Fig-107.

I've poured over the G-Code and can find no error so therefore no reason that the Denford suddenly changed from following the instructions and simply moved the table along the Y axis, and since I wasn't watching at the time I doubt that I'll fathom what went wrong.

I stopped it before it had completely cut deep enough to sever the two halves and I suspect that I can glue in a 2mm thick piece of Walnut to recover it. The concern is that it will happen again on the next blank so I'll have to watch every pass - just in case. It will be prudent to split the cutting of the outline into two sections, the first going down to (say) 8mm in 1mm increments and the second

After some deliberation - read ignore the problem and do something else - I switched the Denford off and closed Mach3, left it for a while then re-started both. The first thing that has to be done on starting Mach3 is to [Zero] the axes. This showed that the Axis registration was way out and I now suspect that the 'X' Axis motor or the ball-screw had jammed but the 'Y' Axis continued to operate.

starting at 8.5mm, going to 11mm in  $\frac{1}{2}$ mm increments. That will at least address the issue of the ribbed finish that the burr creates when using full mm pitch cuts and might stop a repeat 'rogue' cut.

I have plenty of thin sections of Walnut so it didn't take long to trim a piece down to 2mm and glue it in to the damage and that is now curing overnight.
