FermZilla Leaking lid

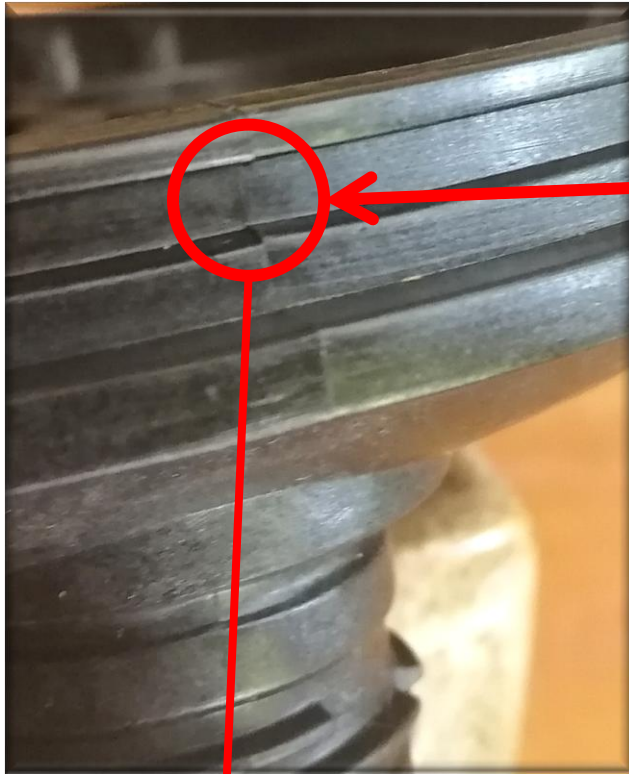
The problem seems to be on the tooling line, there is a small ridge

Inside the o-ring seat, where the injection moulding tool is not quite aligned and leaves a small step. I think that could be the problem.

This is happening on both sides of the lid.

Fortunately, this can be quite easily fixed.

Just use a small key file to smooth out the step, then use some 400 followed by 1000 grid sand paper to polish it out.

Do this gently and it is like the step never existed.

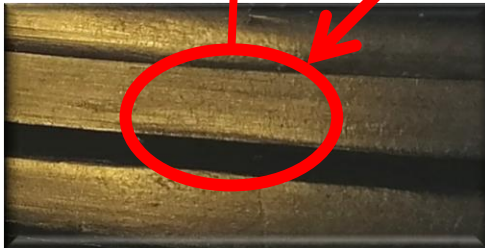
After sanding and polishing.

I believe this will fix the leak.

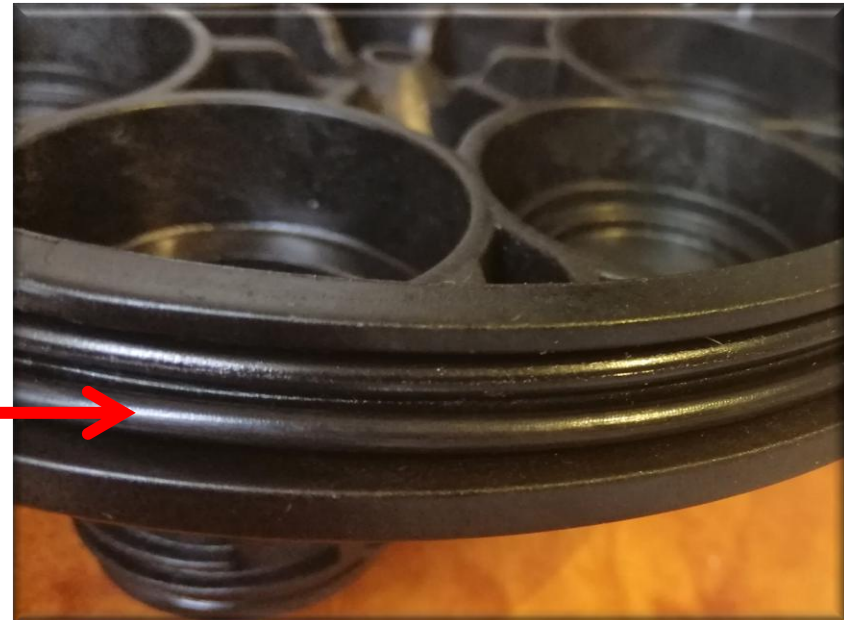
However, if this is still not working. You can place a second o-ring under the lid like this (spare o-ring comes with the kit).

But I think this is a over kill and I would only use it if the above does not work.
