5TH NOV

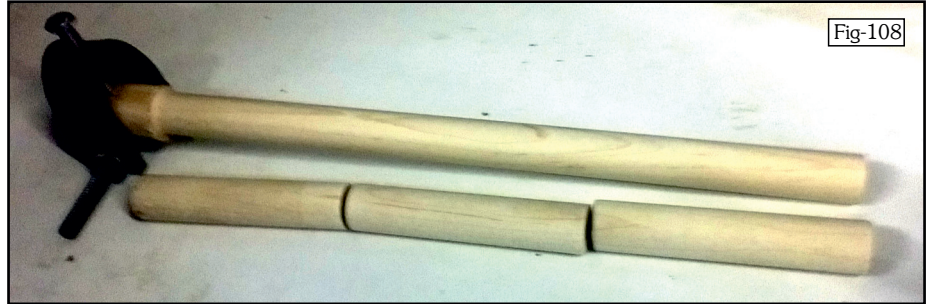
Not quite 'complacent' but I have been making the Frame Spacing struts which I started a couple of days ago whilst still watching the Denford. Rather than drive them with a Collet Chuck (they wouldn't fit in the largest I have) I turned them 'between centres'. A total of 12 are needed (3 per clock) - 16mm Ø and 78mm long with a 1/4" hole. There needs to be some small clearance to allow for minor adjustments and the clamping screws will be 6mm Ø with M5 threads on each end. I made 4 lengths at just over 300mm long so I could afford to grip the first 20mm in a carrier (Fig-108) and still cover the 3 - 80mm lengths.

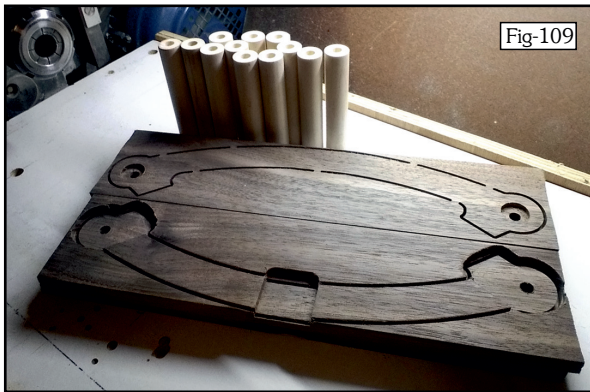
Serendipity reigns it seems because when I designed the Dial, I put the stand-off/location pads at 160mm apart which is a multiple of the 40mm grid spacing on the Denford Table so I can use the existing screw holes and just make locating pegs to fit the already drilled holes in the Front Frame B section. More than that, the head of a standard M4 Button Head screw is 7.3mm Ø and the holes I want to locate are 6.8mm Ø so could easily be turned down to fit the holes. Using CorelDRAW! it is a simple matter to draw two circles at 160mm centres, align them with the grid pattern and export a .DXF file ready for CamBam to create the G-Code to cut just the recesses. So no need for positioning blocks, I just had to put the B sections on the two machined screws and clamp them down.

In Fig-109 you can see both sides of the Front Frame B section before I separate the component from the blank by sawing through the holding tabs. In the background are the Frame Spacers. The change from using the (CamBam) default holding tab dimension of 3 x 3mm Triangular to 4 x 4mm Square has made second operation surface skimming much less demanding

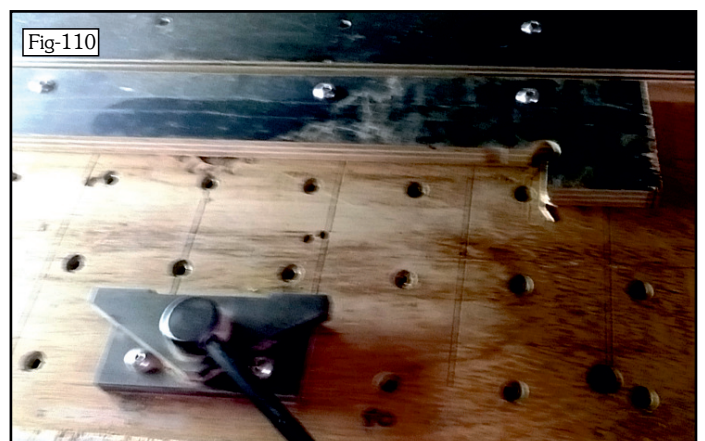
I thought the Front Frame C section were going to be very straightforward since all the joints are on the same side so there isn't a potential 'alignment' problem but in any case I'd decided that screwing a piece of scrap material to the table and cut it by CNC to exactly where the blank needed to be (Fig-110) gave me a very solid 'Location' clamp. I'd also written the joint depth on the drawing in CamBam to remind me that they aren't all the same - however I hadn't reckoned with the Denford wanting to assert it's authority!

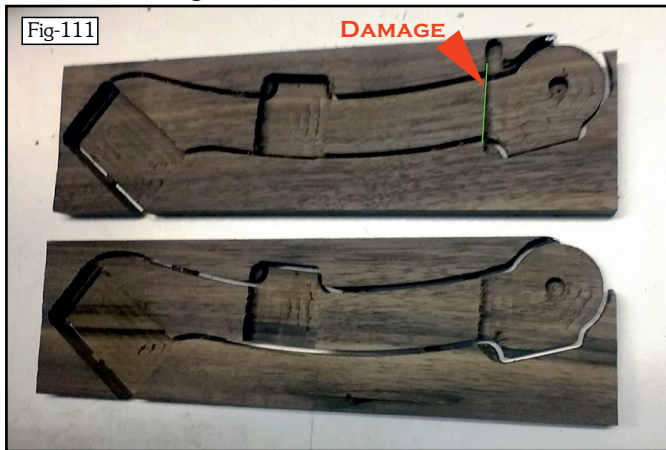
The X axis motion failed twice out of the four, causing some damage to one joint shoulder - the same joint in both cases. This may mean that I have to fit a small wedge of Walnut which will unfortunately be at the front but may be masked by the Dial - until I do the trial assembly I won't know. In Fig-111 the lower component is good and you can see the damage in the top one. I suspect that there will be no more than 1mm taken off the shoulder which should be at a small angle (Green Line) but due to the X axis lock up has been cut square.

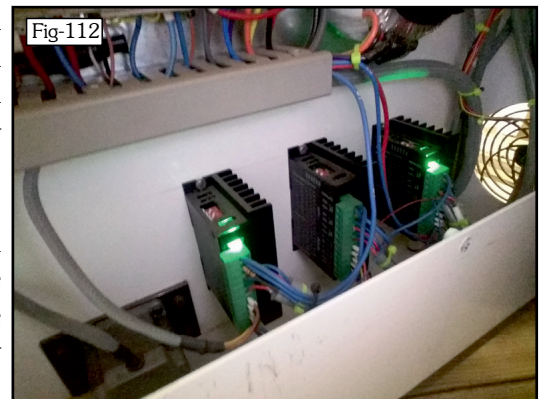
Naturally I have been investigating what might be causing this problem and have discovered that rather than the X axis motor or Ball Screw seizing up - which would be a serious issue needing difficult intervention - it seems that the X axis Stepper Motor Driver is switched off. I only found this out when I opened the back of the Denford to look at the 'Electronic' bits and in Fig-112 you can see that the middle SMD has no 'light' - therefore switched off.

Turning the Denford Off and back On brings it back so it seems that it may be some sort of 'overload' protection might be being triggered but that is only a guess suggested

by the previous owner. I'm now looking at the precise point at which the Driver was turned off and suspect that it might be connected with the location of the [Holding Tabs]. Though why it doesn't happen on *every* occasion is weird - inconsistency always defies logic and I may have to raise a question on the CamBam forum.
