The first 'Build' has revealed some issues - as was to be expected - nothing particularly onerous but certainly needing attention. There seems to be no problem with the gear teeth 'binding' but there is an issue with 'wobble' - that is with the Gears not being absolutely perpendicular to their spindles, but it may be more to do with warping or cupping of the timber.

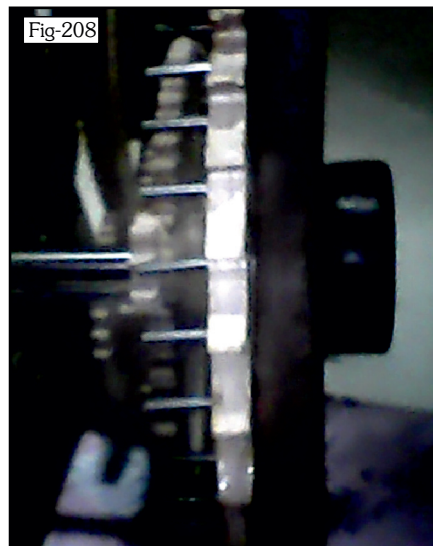
An easy solution to this was to re-cut the Support Pivot Bush recess 1mm deeper thus putting the screw head at least flush with the frame. In Fig-208, which is a photo taken from the top of the frame, you can see that I haven't given myself a great deal of lea-way.

This first showed itself with the Escape Wheel where I designed in quite a small space between the Frame and the back of the Wheel - 2mm - so as it is 120mm Ø and only 5mm thick, a small warp of 1mm should not be unexpected but couple that with the fact that the head of the Latch & Finger Support Clamping Screw stands about 1mm proud of the frame and there will be no clearance :(

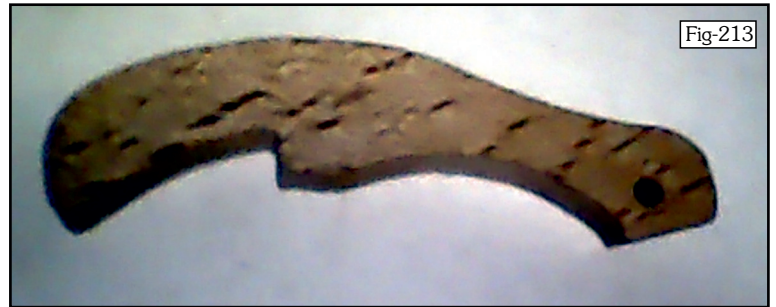
After re-building the clock and mounting it for further tests, adding the weight seemed perfectly normal but after a few swings of the Pendulum it plummeted to the ground!!! It was disappointing to discover that two of the retaining pegs on the Pawls had broken away allowing the Winding Drum to 'free-wheel'.

Fig-212 is the outline drawing of the Pawl and Fig-213 is the broken Pawl.

Since the Pawl is such a small component I suspect that I could have foreseen this possibility -- it doesn't make it any more palatable -- but I think that making the replacements from Tufnol may be a better option, though increasing the size of the retaining peg (al la Fig-212 dotted red line) could be a way to maintain the 'Wooden' element. I'll make that decision tomorrow.
