# The V-Tail Bonanza— Breaking of a Legend

Reprinted from the February 1, 1980  
issue of The Aviation Consumer

Beech's V-tail classic has a disturbingly high record of in-flight airframe failures, while the straight-tail 33 and 36 Bonanzas almost never break.

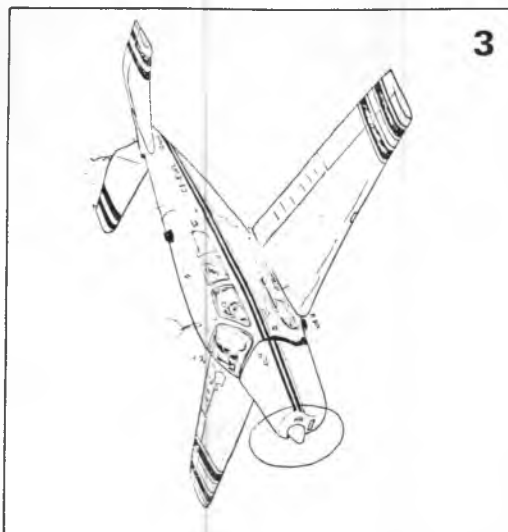
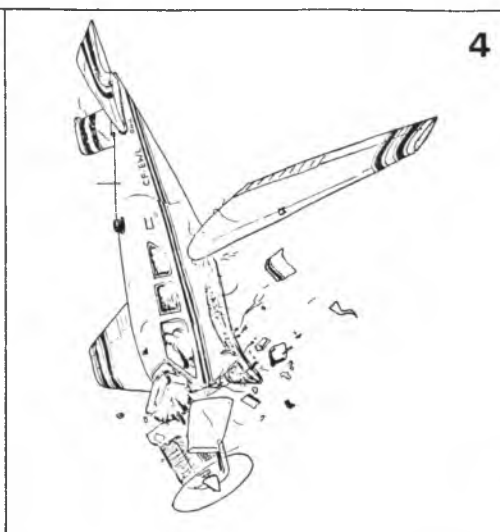
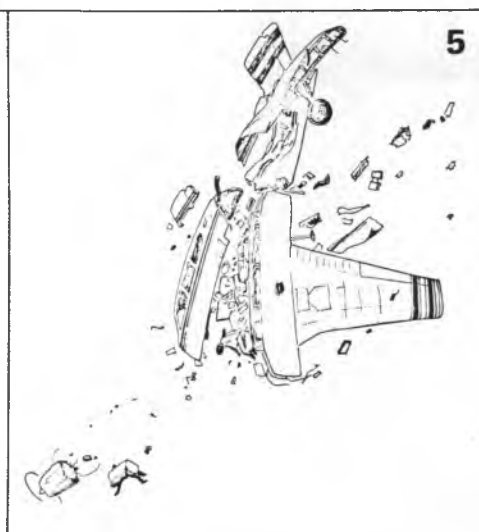
Having given up on fixing the wing problems of the straight 35, Beech continued to strengthen later models. The A35 and subsequent models were designed to 4.4 Gs, instead of the minimum 3.8 Gs used in the straight 35. While Beech found a great improvement in the structural failure rate after this change, the problem did not go away. Where it went, to some degree at least, was back into the tail. Instead of originating in the wings, most of the failures now started in the tail. An ex-Beech accident investigator said the failures "followed a changing

pattern over the years. With the early models, the wing would fail and the entire tail would come off as a unit. But as Beech beefed up the wing and increased the chord of the stabilizer, the more recent ones had an entirely different break pattern. These later models seem to fail in the fins; the fin leading edge folds over—either up or down—sometimes symmetrically, sometimes asymmetrically.”

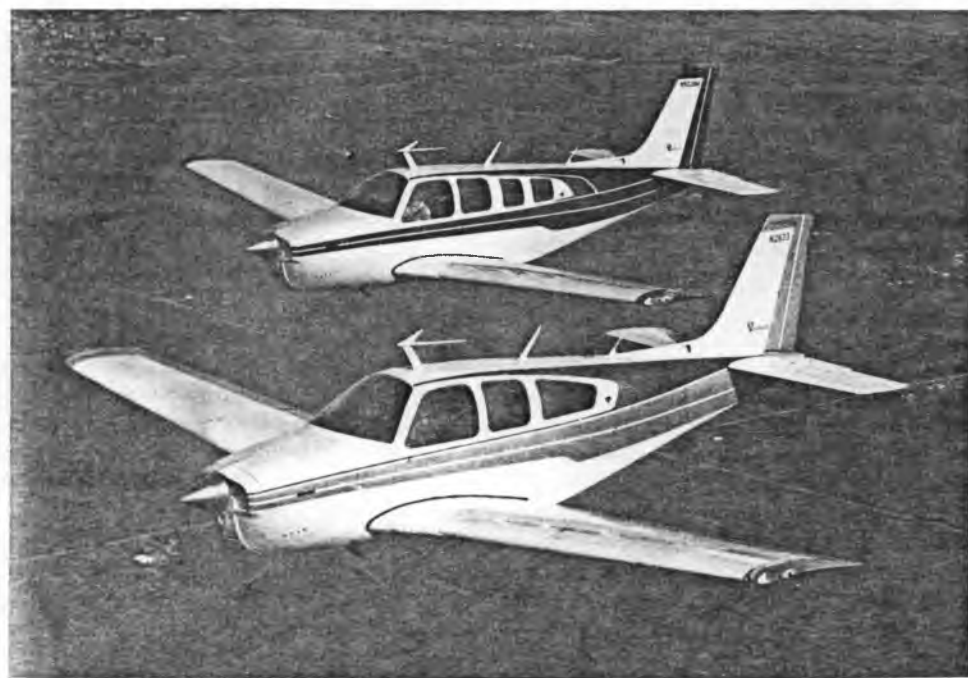
The straight-tail Bonanzas have a superb record of structural integrity—only one breakup in nearly 20 years. F33A (foreground) is virtually identical to the V35 except for the tail. A36 (rear) has stretched fuselage and higher gross weight.
