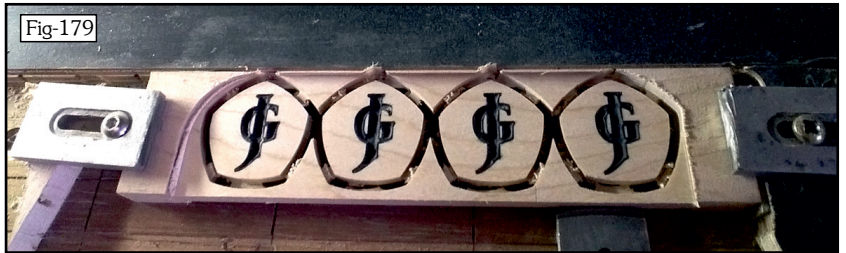
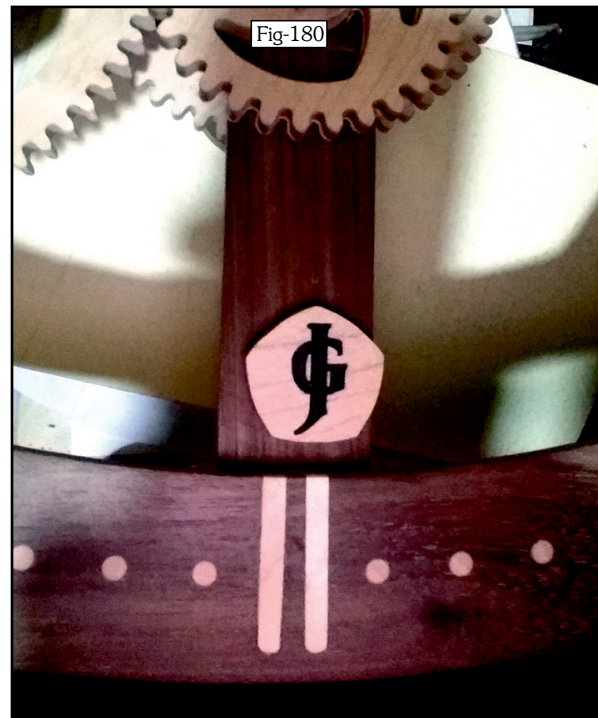
I only discovered this when I came to attach one to the mock assembly and was puzzled by

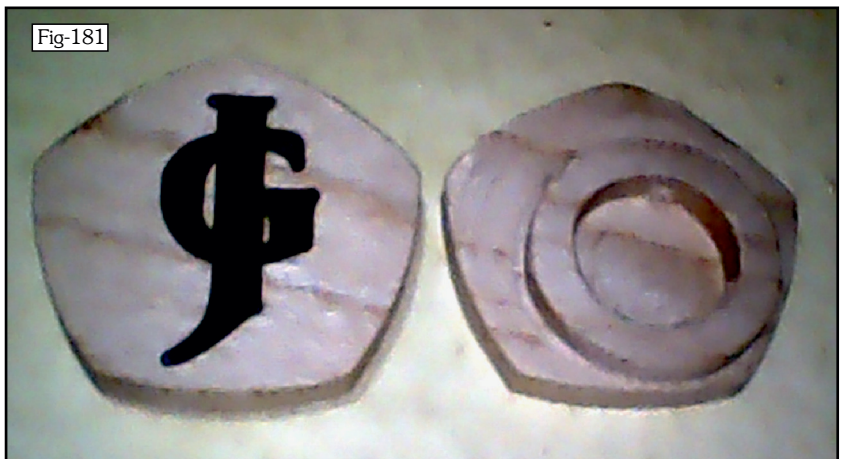
It took me a while to fathom what was wrong and only resolved when I came to photograph two of the plates side by side to demonstrate how they are fixed that I couldn't align the boss correctly.

I thought that I had been meticulous with positioning the various elements (Pentagon, Circle... which are on opposite sides) accurately and also central to the blank which had to be turned over and was surprised when the surface clearing cut was about 1.5mm out. Without much thought, I made an adjustment after flipping the blank so I suspect that that was my main error.

I've just measured the position of the surface clearing polyline in the CamBam drawing and find that it is NOT central on the blank :(There is a difference of about 3mm (I wasn't looking for micron accuracy!) so that does seem to explain it.

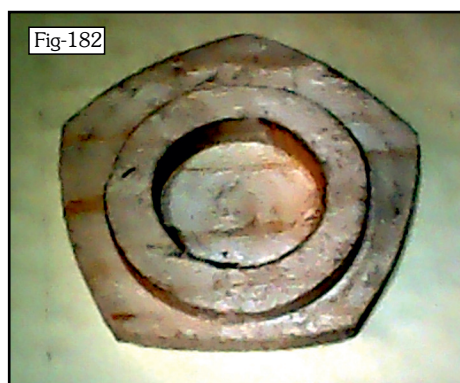
Fig-182 is the back of the 'One that got away' (recovered) showing that the mounting boss IS in the correct place and Fig-183 shows the remaining three waiting for the paint to dry before the final skim. I've already done a 0.1mm skim but there were depressions in the paint fill so I've applied another coat which will be skimmed again later today.

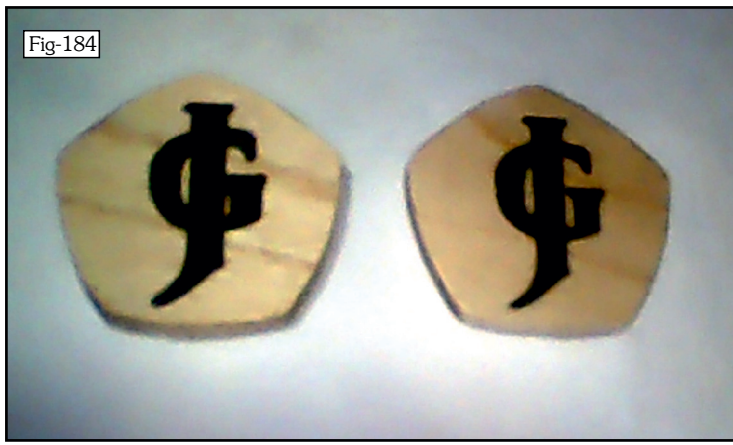
With just a little experience of the effects of engraving depth and very minor adjustments to the original outline (tenths of a millimetre) it surprises me how much improvement there is to the finished work.

On the left of Fig-184 is the first attempt, which went wrong due to the mis-placed fixing boss, with the deeper cut and surface painted monogram and on the right the second attempt cut only 0.3mm less deep and fully filled with Acrylic Paint.
