27TH OCT

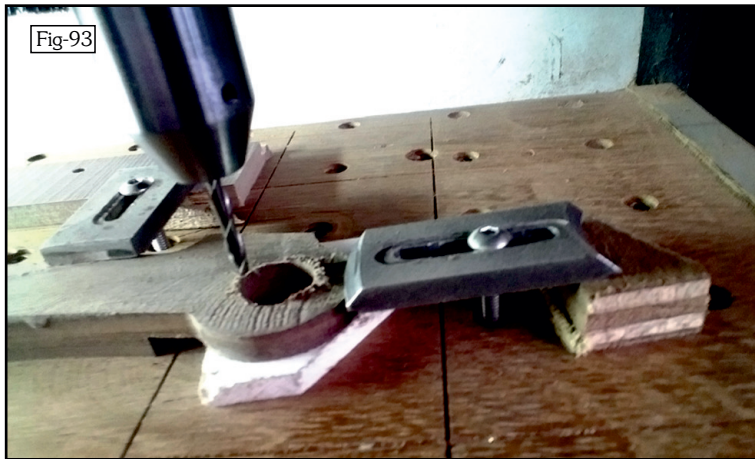
As it happens, the chatter damage *can* be seen on the Phone Photo' (Fig-93) but the Endoscope image (Fig-94) makes it more visible.

Having cut the recess I took a photo' to show the clamping strategy but then thought that I could also try-out the endoscope to see if that would pick up the 'chatter' damage. It took a while since I had to install first Zoom, to give the Endoscope somewhere to display the image, and then Photoshop so that I could display the screen-grab.
